Piotr STRZAŁKOWSKI¹, Roman ŚCIGAŁA²

**DISCONTINUOUS DEFORMATIONS IN MINING AREAS - THE ANALYSIS OF
OCCURRENCE CONDITIONS**

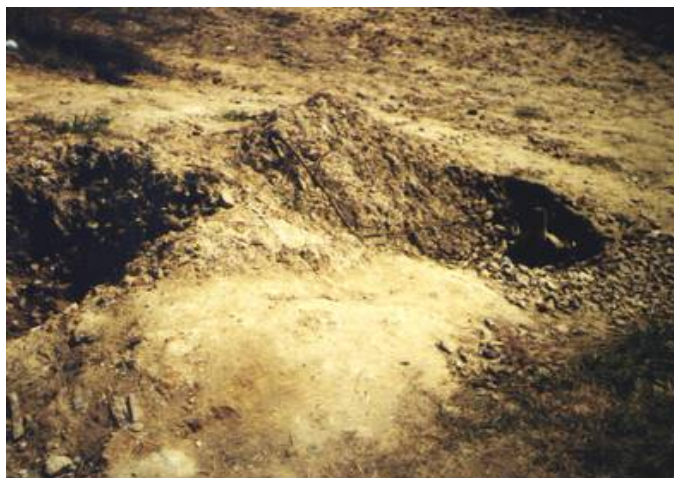
Fig. 6 Sink holes 8 and 9, occurred in the Głowackiego street.

- ❑ sinks no 8 and 9 with diameters 2.0 m and 3.0 m and depth : 0.5m and 1.0m. They occurred in the year 2000 in the area of waste land.

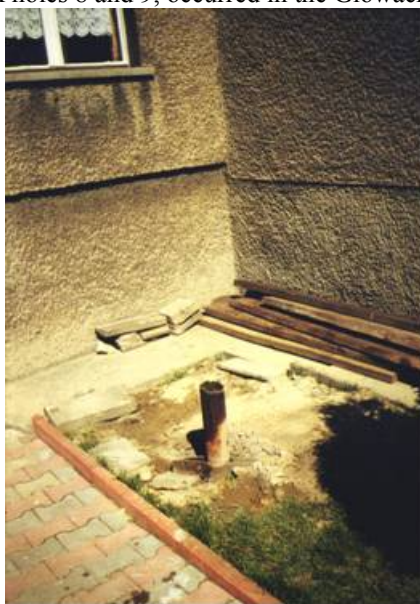
Fig.7 Filling in the underground cavern in the area of sinks 7

- ❑ sink no 4 of elliptical shape with diameters : 3.5m x 2.0m and depth 1.5m occurred in the vicinity of local road.
- ❑ sink no 5 with diameter 3.0m and depth 2.0m occurred in apartment house corner . It was liquidated by sand filling. Several years later, in the year 2000, it occurred again (sink no 7 – fig.7) and was liquidated by injection of multicomponent mixture composed with use fly ashes, directly to underground cavern. Due to the deformation, building construction was partially damaged.
